# VILLAGE DAMAGE SUMMARY: TKVIAVI, GORI DISTRICT, GEORGIA

Damage Assessment with WorldView-1 & Formosat-2 Satellite Imagery Recorded on 19 August 2008

UNOSAT-2008-000194

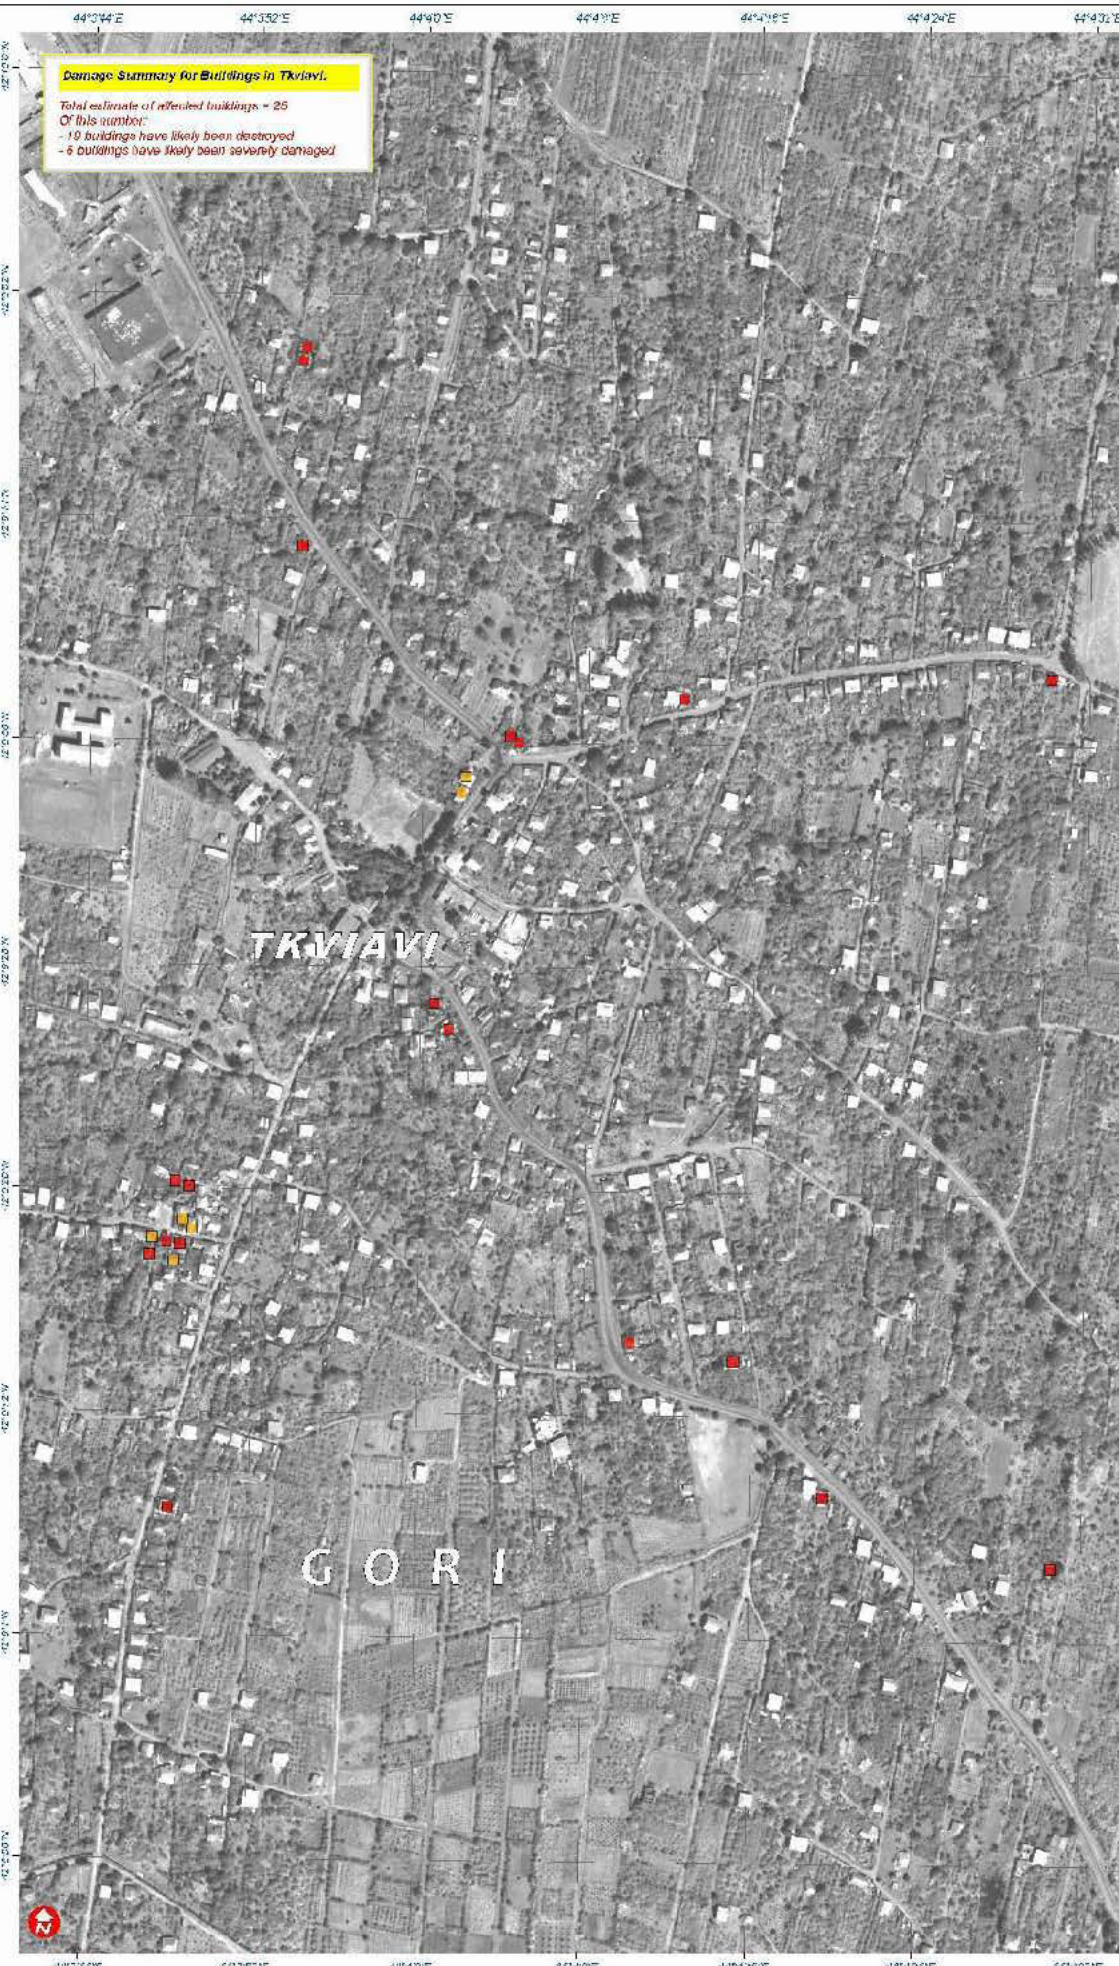
This map presents a satellite-based damage assessment for the affected village of Tkviavi, Gori District, Georgia following the armed conflict between Georgia and Russian military forces, August 2008. Damaged buildings have been identified with WorldView-1 & Formosat-2 satellite imagery recorded on 19 August 2008. Previous UNOSAT QuickBird imagery in Google Earth was also used.

Affected buildings were identified either as destroyed or severely damaged by standard satellite image interpretation methods. Destroyed buildings have been defined either by the total lack of the structure when it was standing but with less than 50% of the roof still visible. Severely damaged buildings were defined as having visible structural damage to a portion of the roof or where a section of the roof was damaged but with over 50% of the roof still intact.

The estimated total number of affected buildings for the selected village is approximately 25. Of this total 19 buildings have likely been destroyed and 6 buildings have likely been severely damaged. An important underlying finding of this satellite damage analysis is the observed heavy concentration of damages within densely defined residential areas.
