# High-Resolution Satellite Imagery and the Conflict in South Ossetia

Summary Report  
October 9, 2008

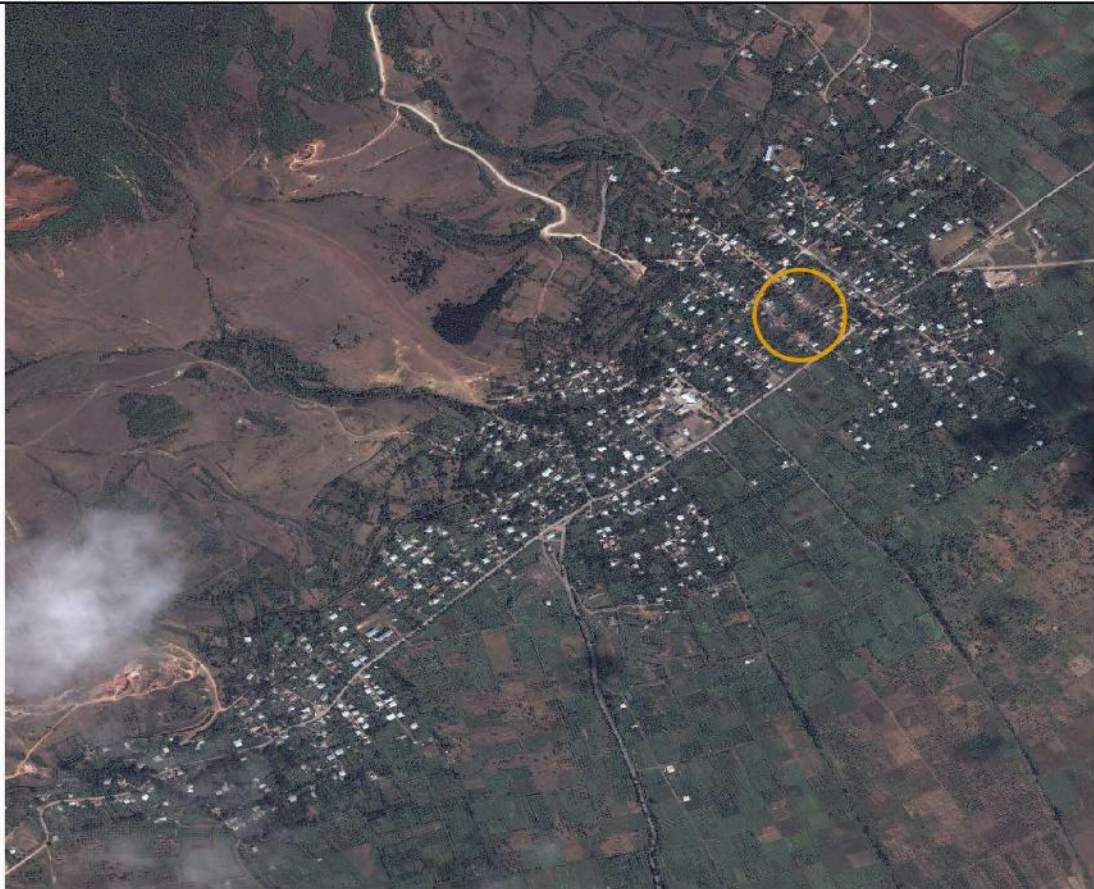
Figure 3A: Damage to the Eredvi-Berula-Argvitsi Region

*Orange circle highlights the 9 structures in the main village area of the region destroyed by August 10, 2008.*

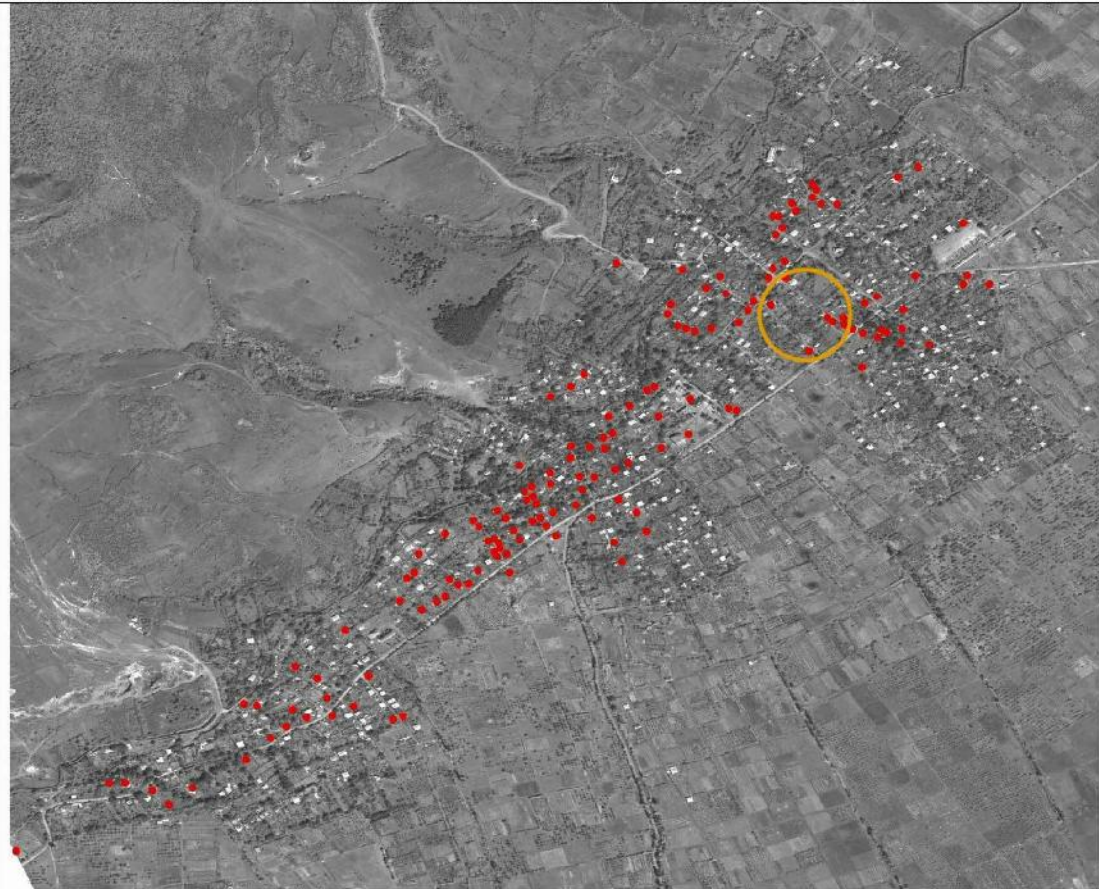
Figure 3B: August 19, 2008: Damage to the Eredvi-Berula-Argvitsi Region

*Village area showing August 10 destruction (orange circle) and August 19 damage (red markers). 147 structures are damaged or destroyed by August 19.*

Berula was a village which sustained major damage in the nine days between the two image dates (Figure 3). There was no observed damage to this location on August 10, and 70 damaged or destroyed structures on August 19. Additionally, the villages of Brotsleti and Tirdzinisi were observed to be damaged only on August 19, with damaged structures numbering 5 and 7 structures, respectively.

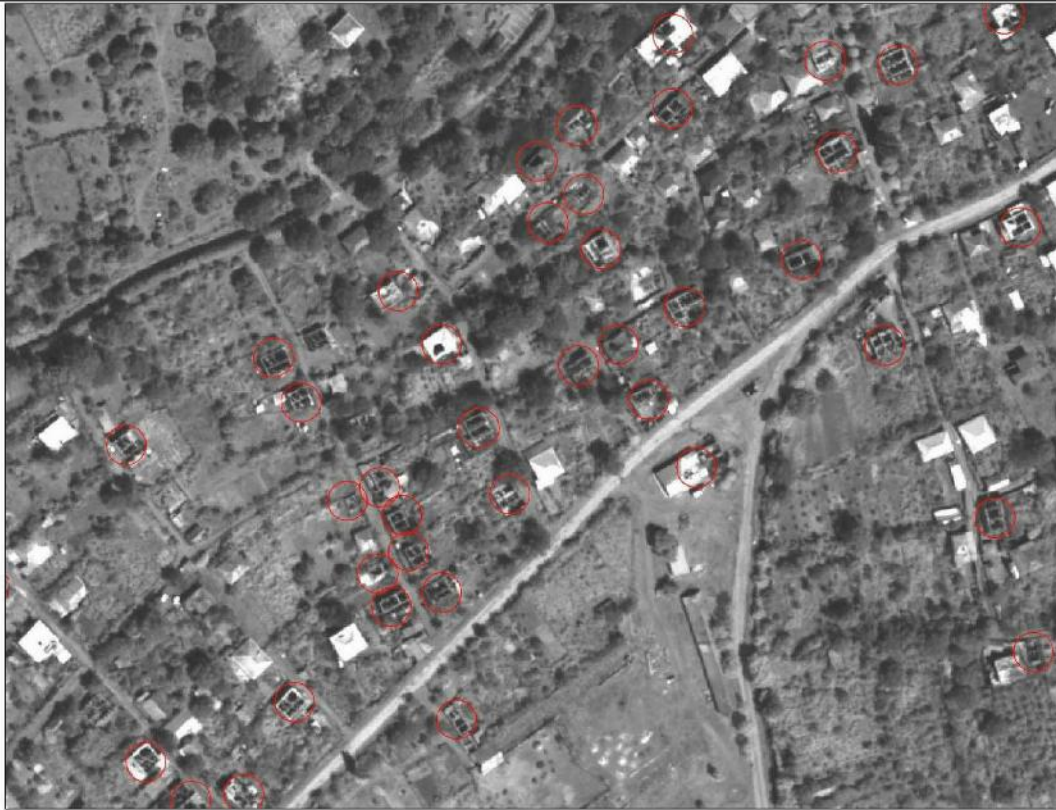
Figure 3C: Subset of damage to the Eredvi-Berula-Argvitsi Region

*Subset of August 19, 2008 image. Red circles indicate damage typical to the region. Damage is apparent, and it can be seen that the roofs of buildings are no longer present, exposing interior walls.*

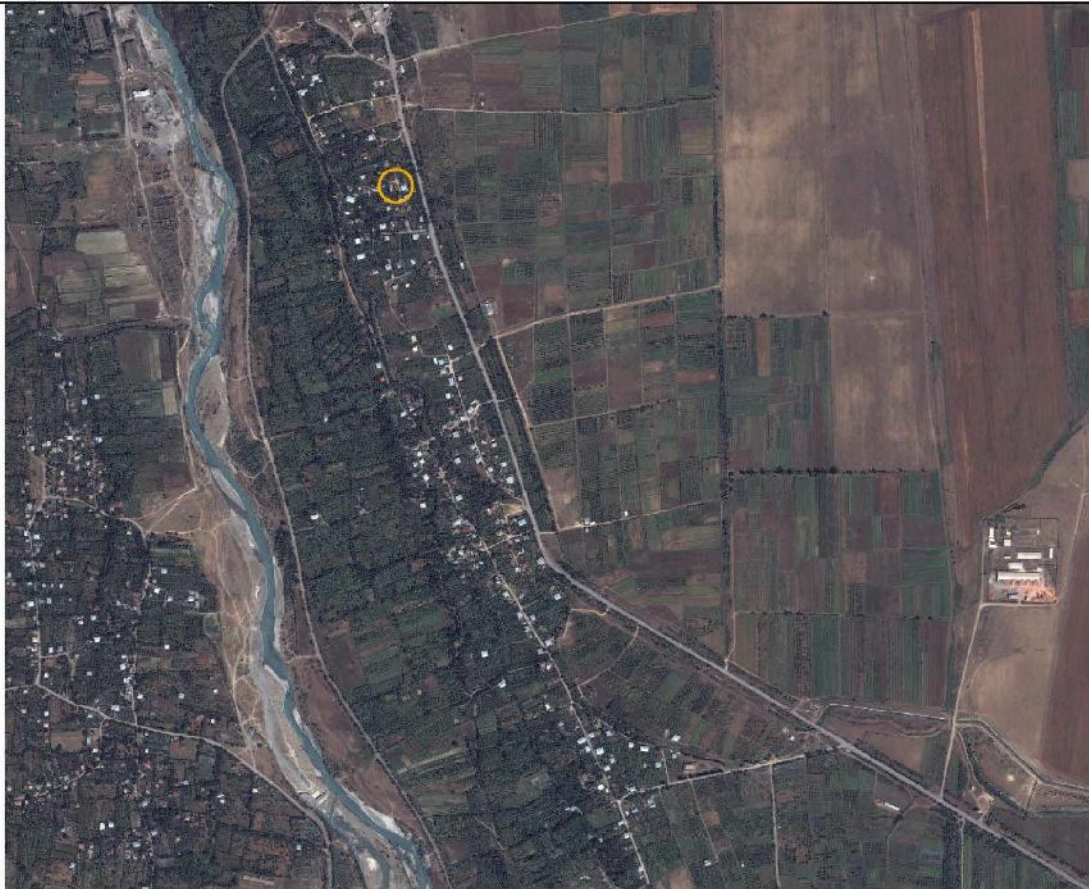
Figure 4A: Ergneti on August 10, 2008

*One damaged structure was identified for Ergneti on August 10.*

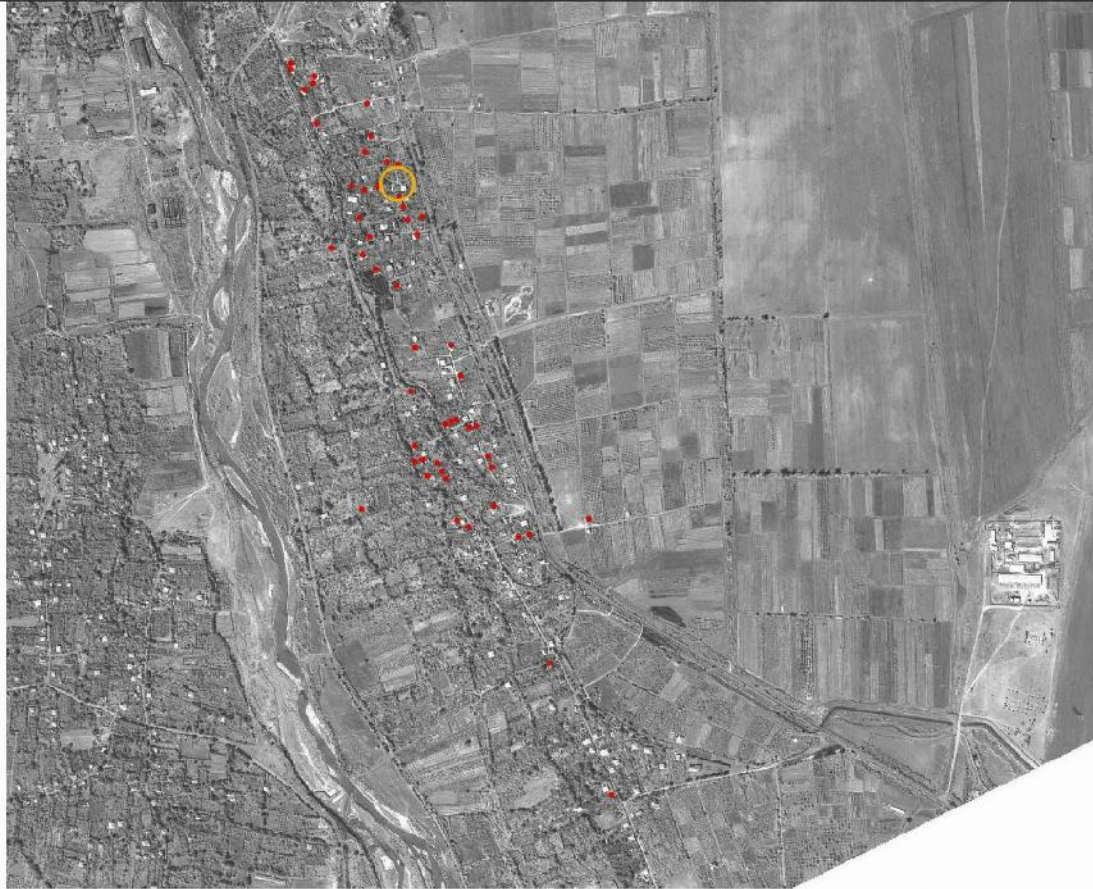
Figure 4B: Damage to Ergneti on August 19, 2008

*52 damaged structures in Ergneti were observed in the August 19 image.*

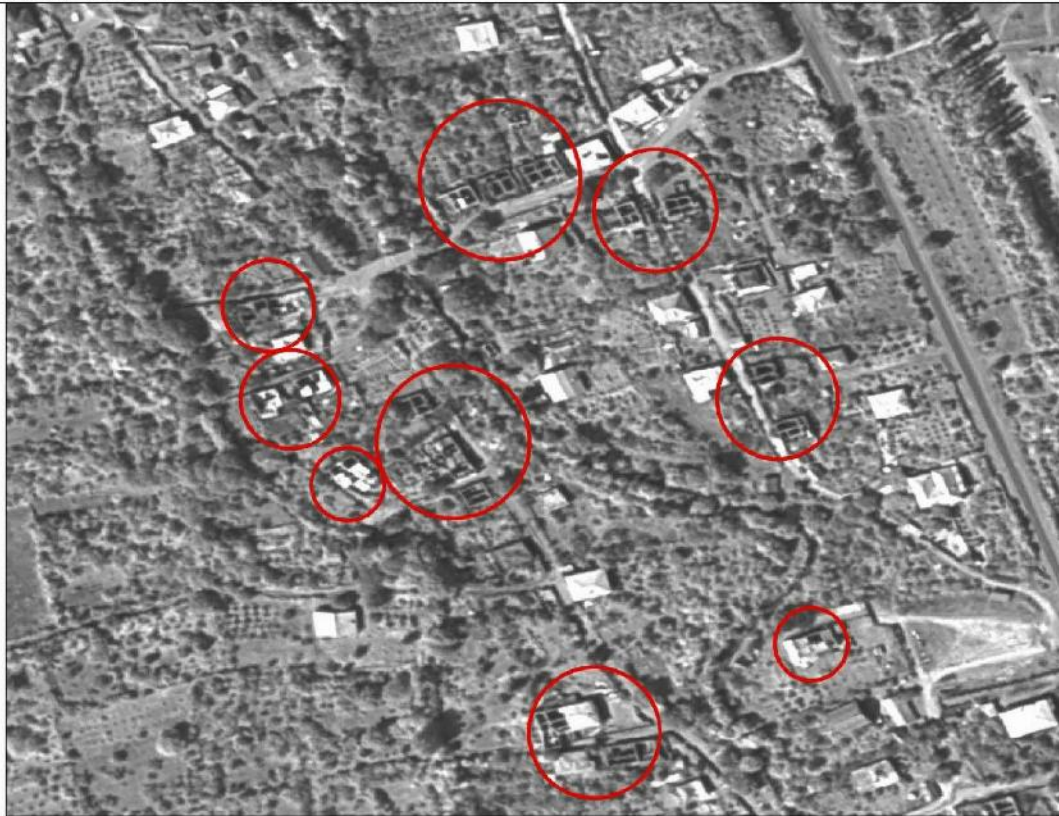
Figure 4C: Subset of Ergneti

*Red circles highlight damaged structures in Ergneti on August 19.*

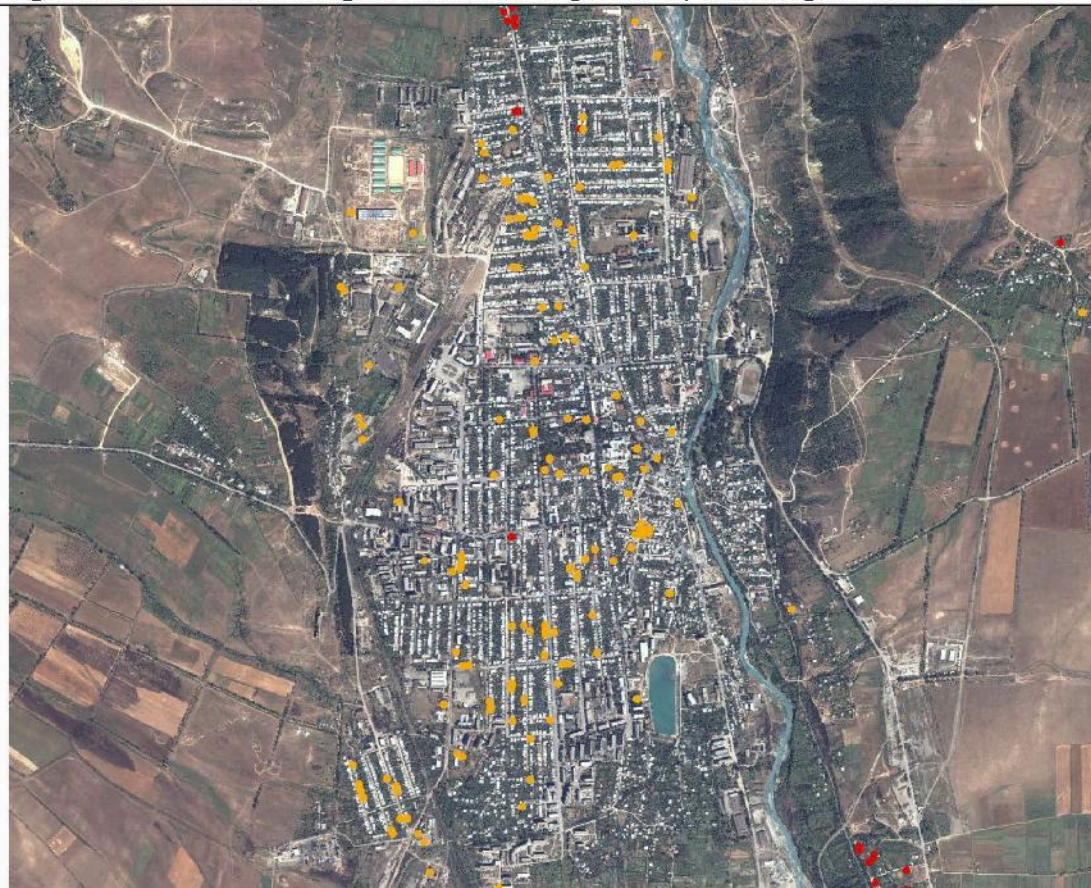
Figure 5A: Tskhinvali on August 10 with damage overlay from August 10 and 19

*Orange dots represent damage present on August 10, red dots on August 19. Dots in the far north and southeast are included in assessments for Tamarsheni and Ergneti, respectively. Note that the majority of damage to Tskhinvali occurred prior to or on August 10, with 182 structures damaged, while only 4 additional damaged structures have been identified for the city on August 19.*

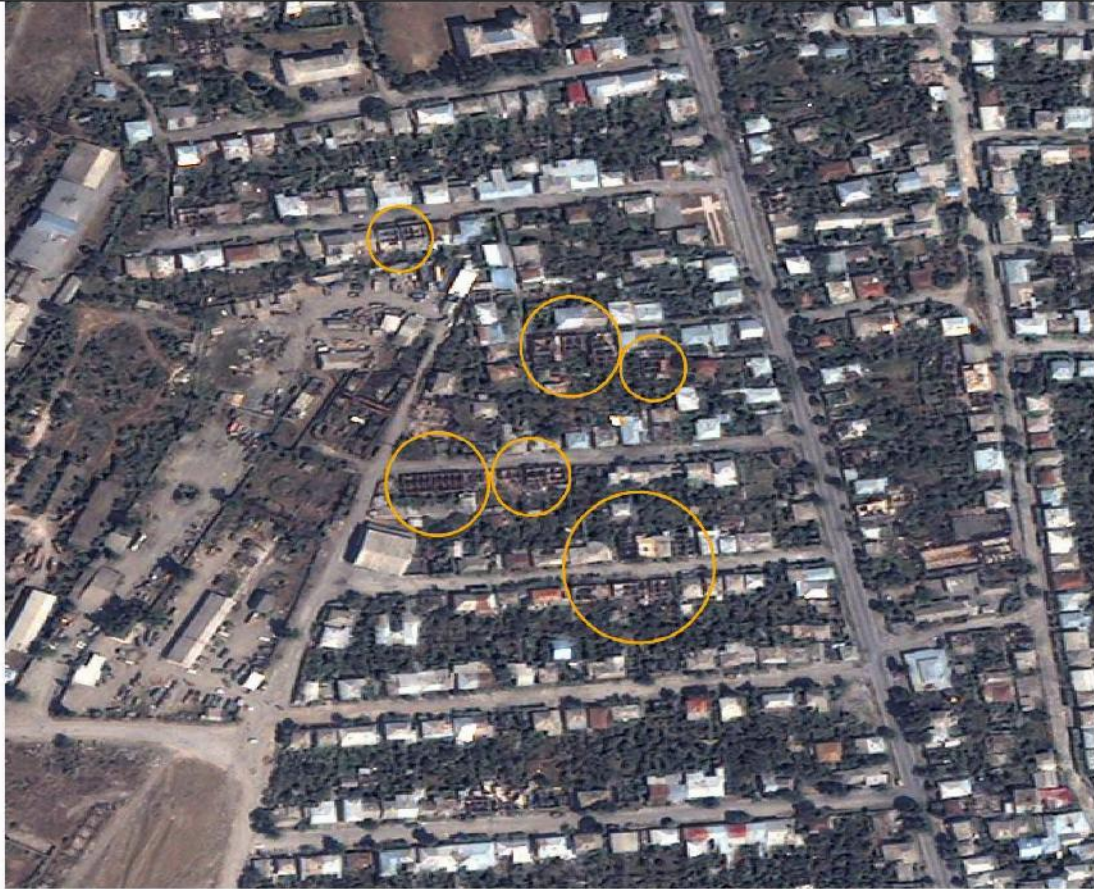
Figure 5B: Subset of August 10 image showing Tskhinvali

*Subset of August 10 image of Tskhinvali city, highlighting damage to multiple structures, covering an area of approximately 0.6 km<sup>2</sup>.*

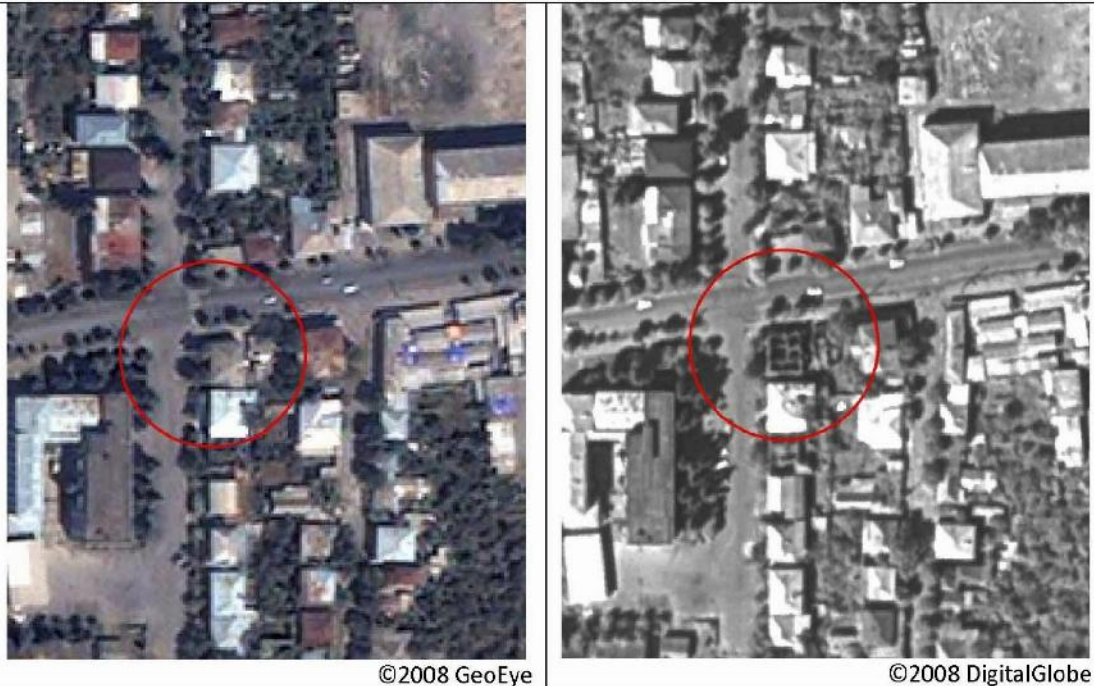
Figure 5C: Subset of damage within the city of Tskhinvali

*Illustration of damage occurring to the city of Tskhinvali prior to August 19, 2008, but occurring after August 10. The building within the red circle is intact in the first image and visibly damaged, with its roof destroyed, in the second image.*

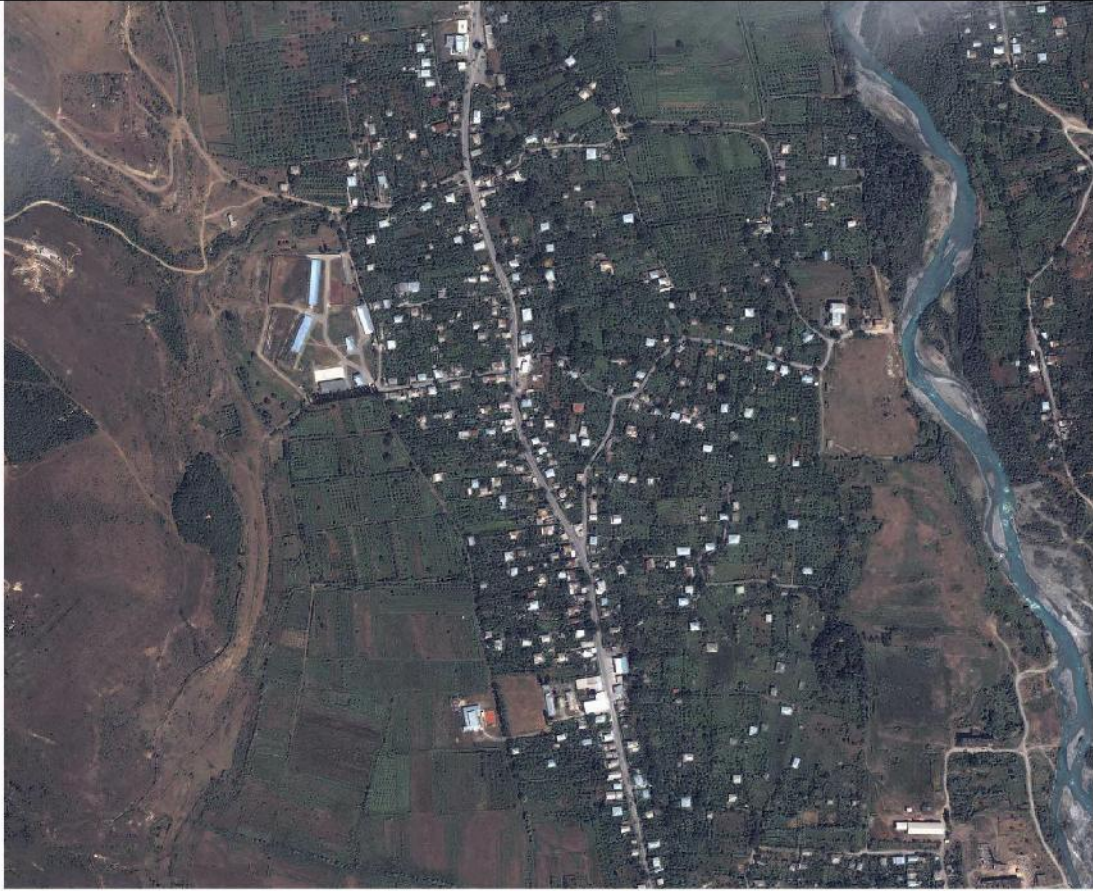
Figure 6A: Overview of village on August 10

*Tamarsheni on August 10. No damage is visible in any part of the image.*

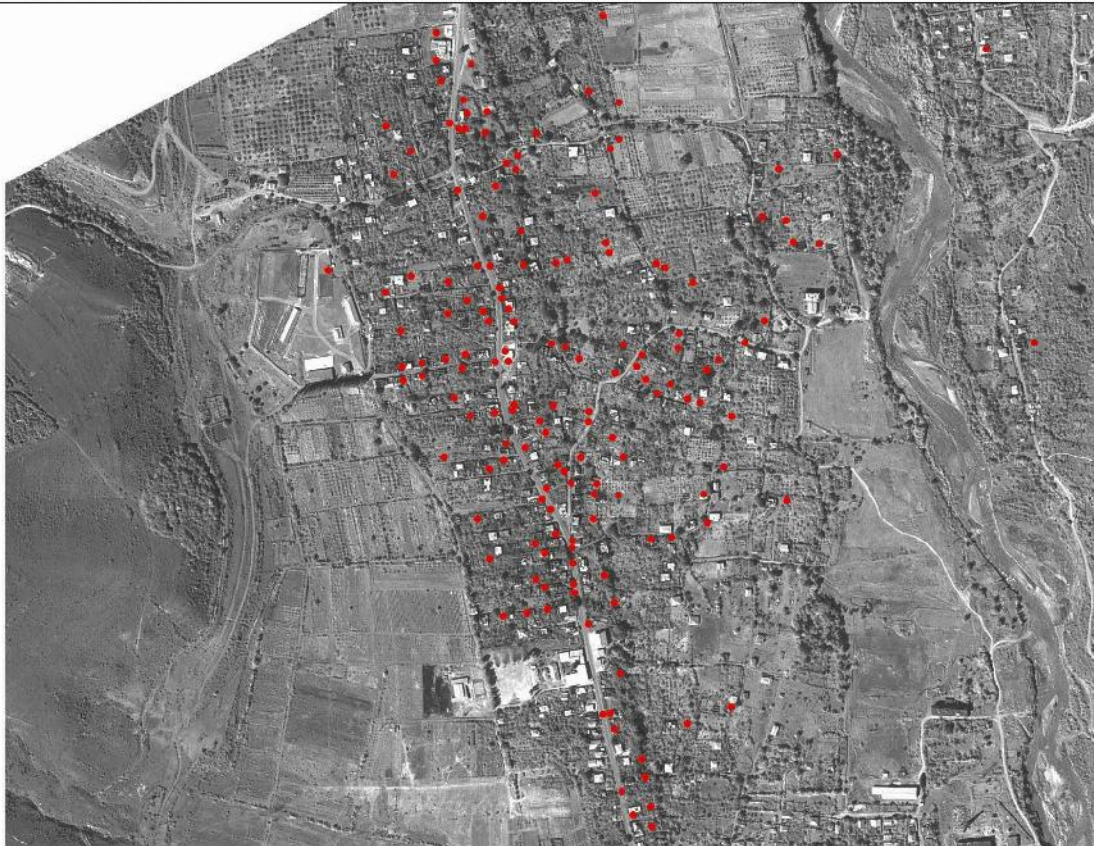
Figure 6B: Overview of Tamarsheni on August 19

*Village of Tamarsheni on August 19, with red dots representing all buildings sustaining damage (152 total structures).*

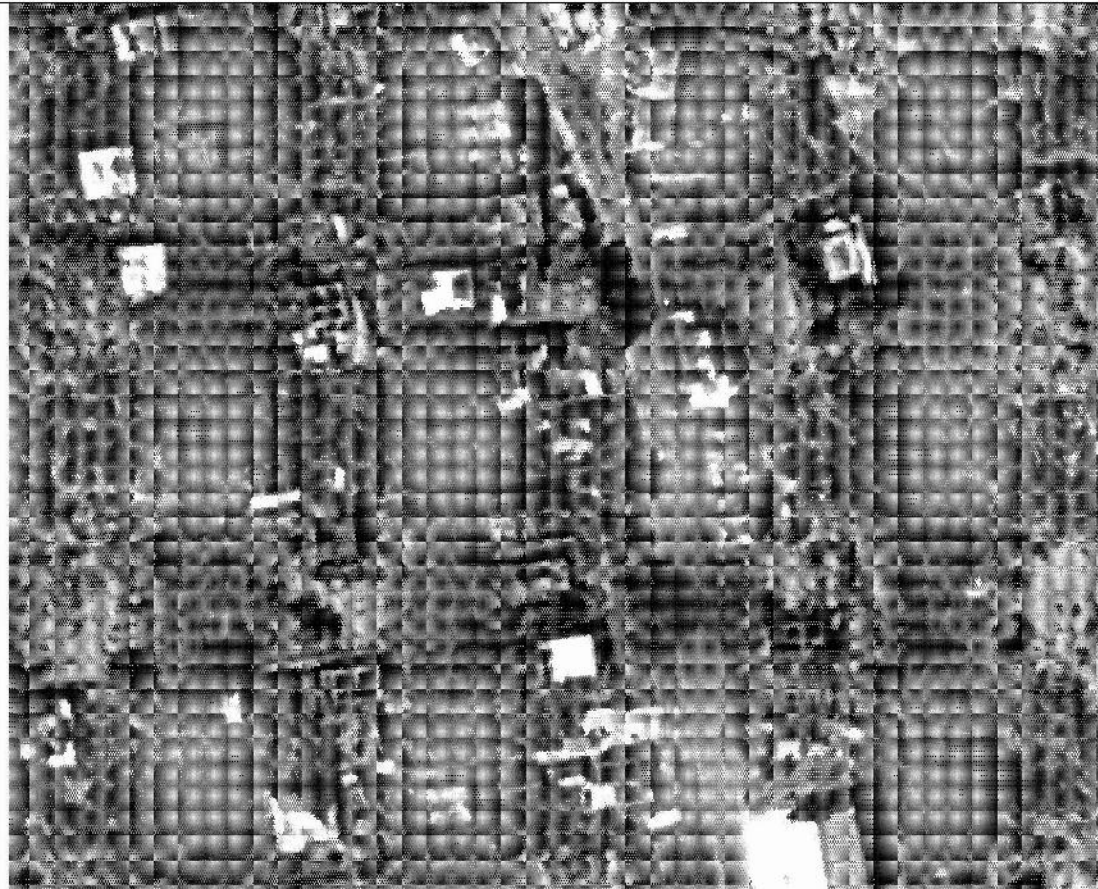
Figure 6C: Subset of Tamarsheni

*Subset of image covering Tamarsheni on August 19. Widespread damage is visible to nearly all the buildings in the area, indicated by their lack of rooftops.*

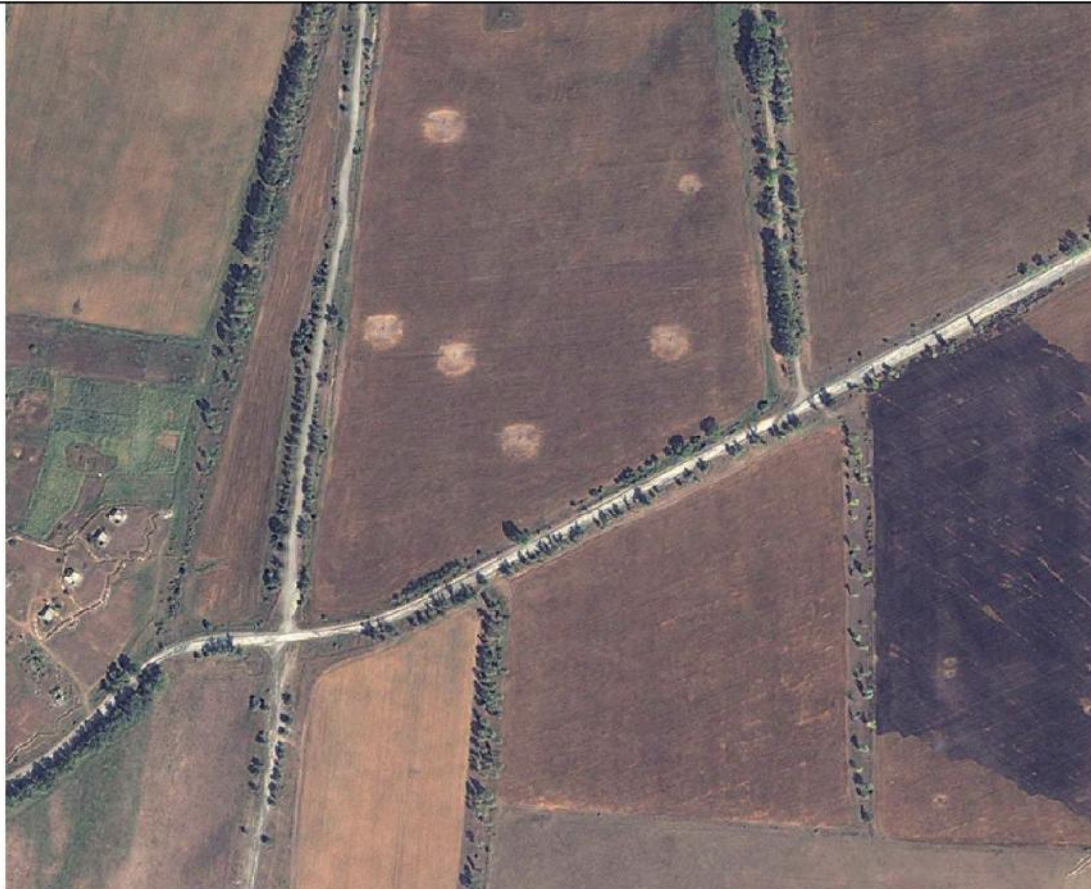
**Figure 7A: Fields and roads outside of Tskhinvali August 10, 2008**

*Portions of the August 10 image, such as the one above, show a lack of military presence in many areas on or before that date.*

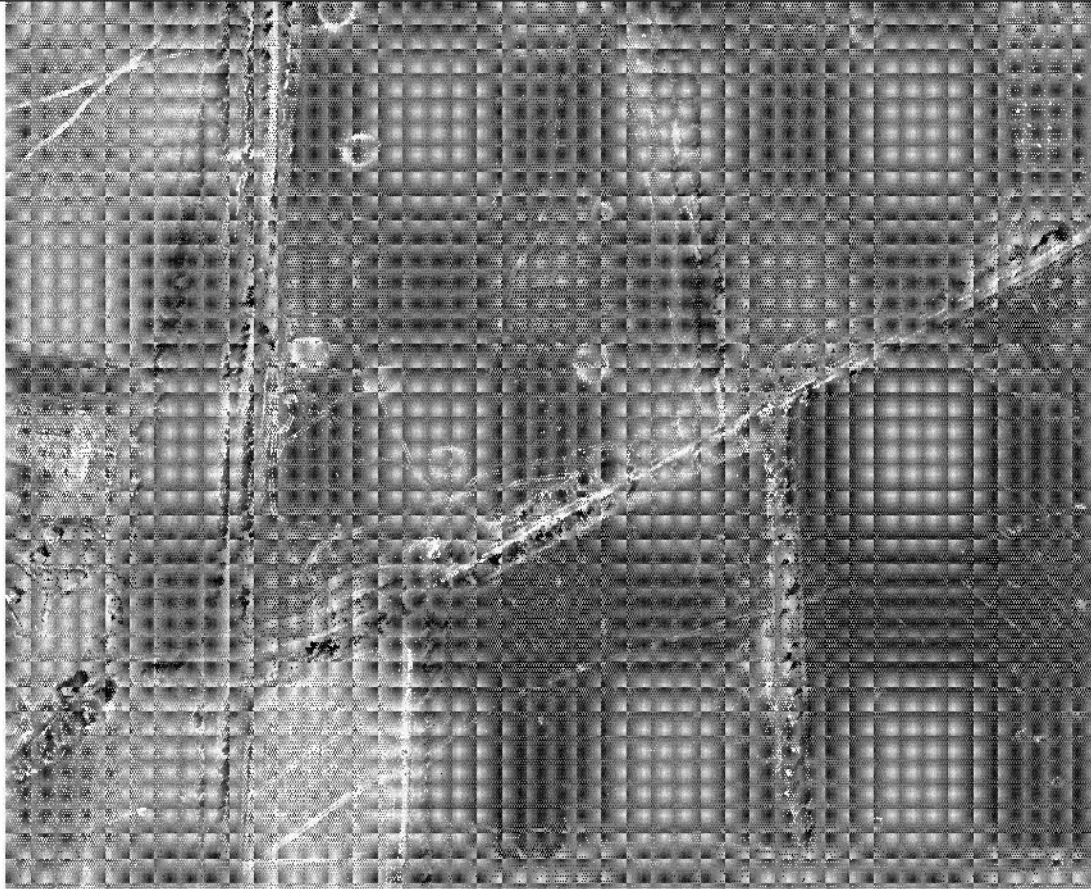
Figure 7B: Fields and roads outside of Tskhinvali August 19, 2008

*Tracks from large vehicles can be seen throughout this image, as well as a large number of disturbed areas on the ground, measuring approximately 3-4 meters in diameter, which are possibly craters from munitions. Note that while the August 10 image is a multi-spectral image (full color) and the August 19 image is panchromatic (black and white), the images are comparable for analysis purposes.*

Although a large amount of the destruction observed in the August 10 and 19 images takes the form of structural damage, there are also numerous other indications of conflict visible throughout the region. In many areas, track marks from large vehicles can be seen crossing agricultural fields (Figure 7 A-B). Numerous craters dot the region, with 455 visible between the two image dates (Figure 7C). Lastly, significant amounts of military hardware, including vehicles, helicopters, and tents, are found throughout the imagery.

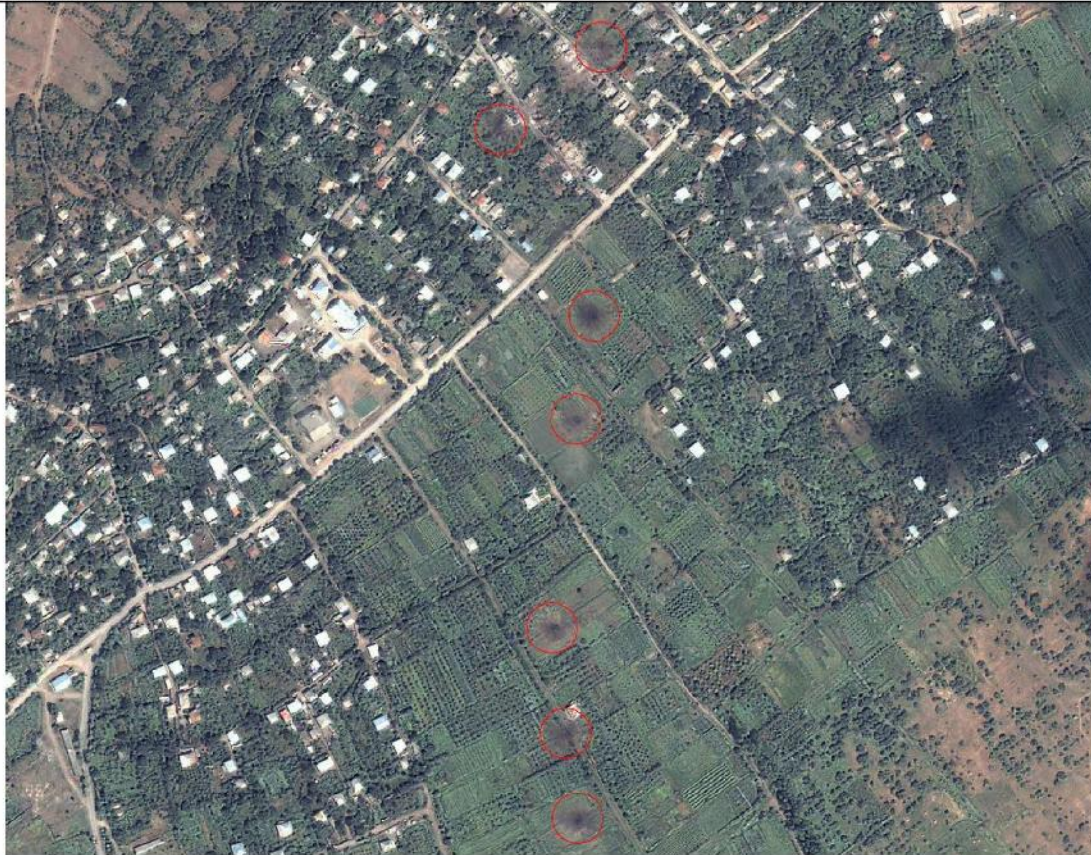
Figure 7C: Signs of conflict near Ergneti on August 10, 2008

*This image subset covering the village of Ergneti highlights further signs of conflict occurring on August 10. The red circles indicate possible craters from munitions, which occur in a roughly linear pattern toward the village. Each circular area has a diameter of approximately 30-40 meters.*
