VILLAGE DAMAGE SUMMARY: EREDVI, BERULA & ARGVITSI, SOUTH OSSETIA, GEORGIA

Damage Assessment with Ikonos & WorldView-1 Satellite Imagery Recorded on 10 & 19 August 2008

UNOSAT-2008-000201

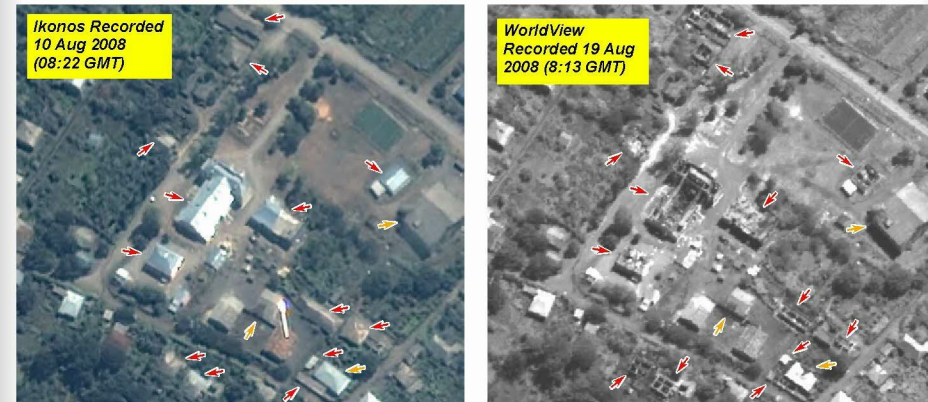
Map Inset 1: Illustration of Damages Occurring between the dates of 10 August & 19 August 2008

Total estimate of affected buildings is 294.
Affected building sub-totals by degree:
- 222 buildings have likely been destroyed &
- 72 buildings have likely been severely damaged.
Destroyed building sub-totals by date:
(12 destroyed before 10 Aug 08 (08:22 GMT)
(210 destroyed between 10 Aug 08 & 19 Aug 08)

Damaged building sub-totals by date:
(5 damaged before 10 Aug 08 (08:22 GMT)
(67 damaged between 10 Aug 08 & 19 Aug 08)
There are an additional 13 suspected impact craters likely caused by artillery. Of this total, 9 occurred before 10 Aug 08 (08:22 GMT) & 4 between 10 Aug 08 & 19 Aug 08.

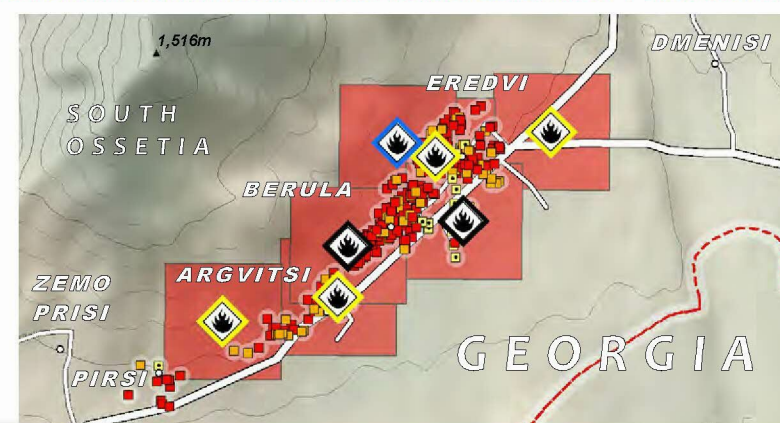
MAP INSET 2: SATELLITE-DETECTED ACTIVE FIRE LOCATIONS COVERING THE PERIOD OF 1 - 31 AUGUST 2008

FIRE SUMMARY:
The earliest date of detected fires over the area was on 12 August, and was distributed from Argvitsi to Eredvi. Fire(s) were also detected over a smaller extent on 13 August. No additional fires were detected until 22 August 2008. Damages resulting from fires detected on 22 Aug. are not reflected in the damage assessment summary above.
