# VILLAGE DAMAGE SUMMARY: NIKOZI, GORI DISTRICT, GEORGIA

Damage Assessment with WorldView-1 & Formosat-2 Satellite Imagery Recorded on 19 August 2008

UNOSAT-2008-000193

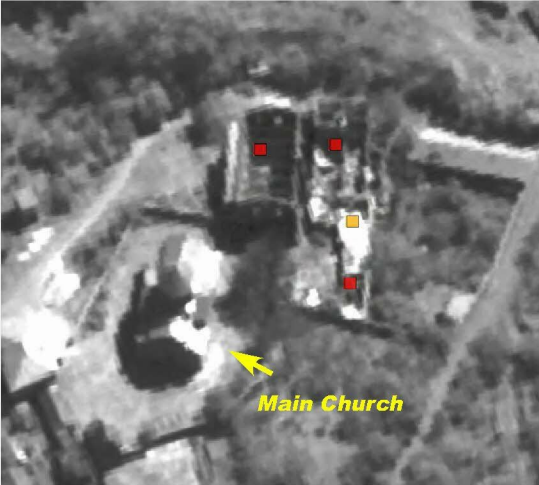
MAP INSET: Nikozi Monastery Complex - 3 buildings destroyed, 1 severely damaged, main church appears undamaged.
